Navajo Abandoned Uranium Mine

Site Screen Report

Deneh Nezz 3 AUM Site

March 2010

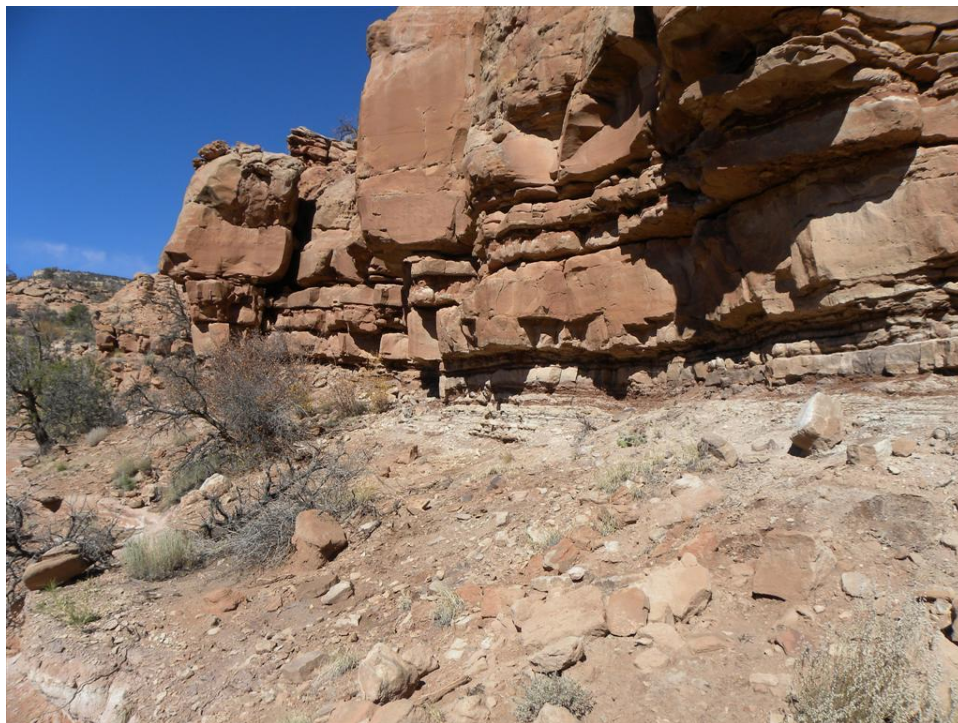
Small waste pile in front of possible adit/rim strip operation, 20' x 20', with a total estimated volume of 74 yd³

Photo 1. Waste pile

Possible adit or rim strip cut into rock face; unreclaimed waste pile

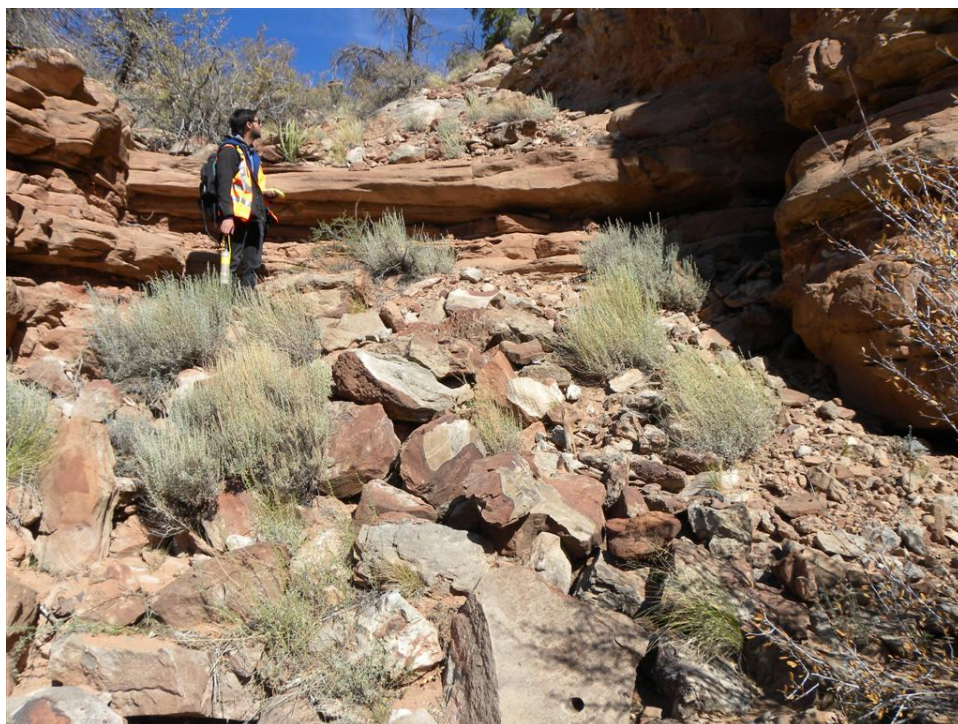
Photo 2. Waste pile

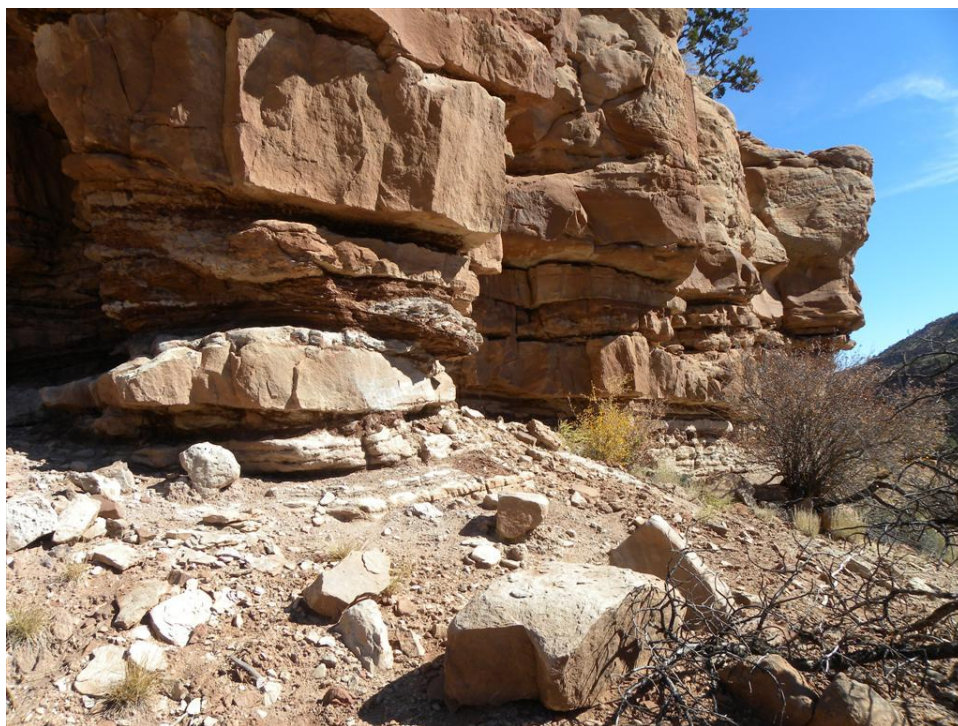
A total of 1,737 gamma radiation measurements were collected from the mine site, ranging from 5,823 cpm to 83,149 cpm. Measurements in the vicinity of the waste debris were found at levels up to 80,000 cpm, and at the possible adit or rim strip cut into rock face from 9,000 cpm (bottom) to 22,000 cpm (top). The measurements are represented in Figures 1 and 2.

Possible adit or rim strip cut into rock face

Photo 3. Possible adit or rim strip cut into rock face
